PENTAGON RENOVATION PROGRAM

MARCH 7, 2002

THE PHOENIX PROJECT

- 400,000 square feet
- The outer three rings (E, D, & C)
- Between Corridors 4 & 5
- All 5 floors

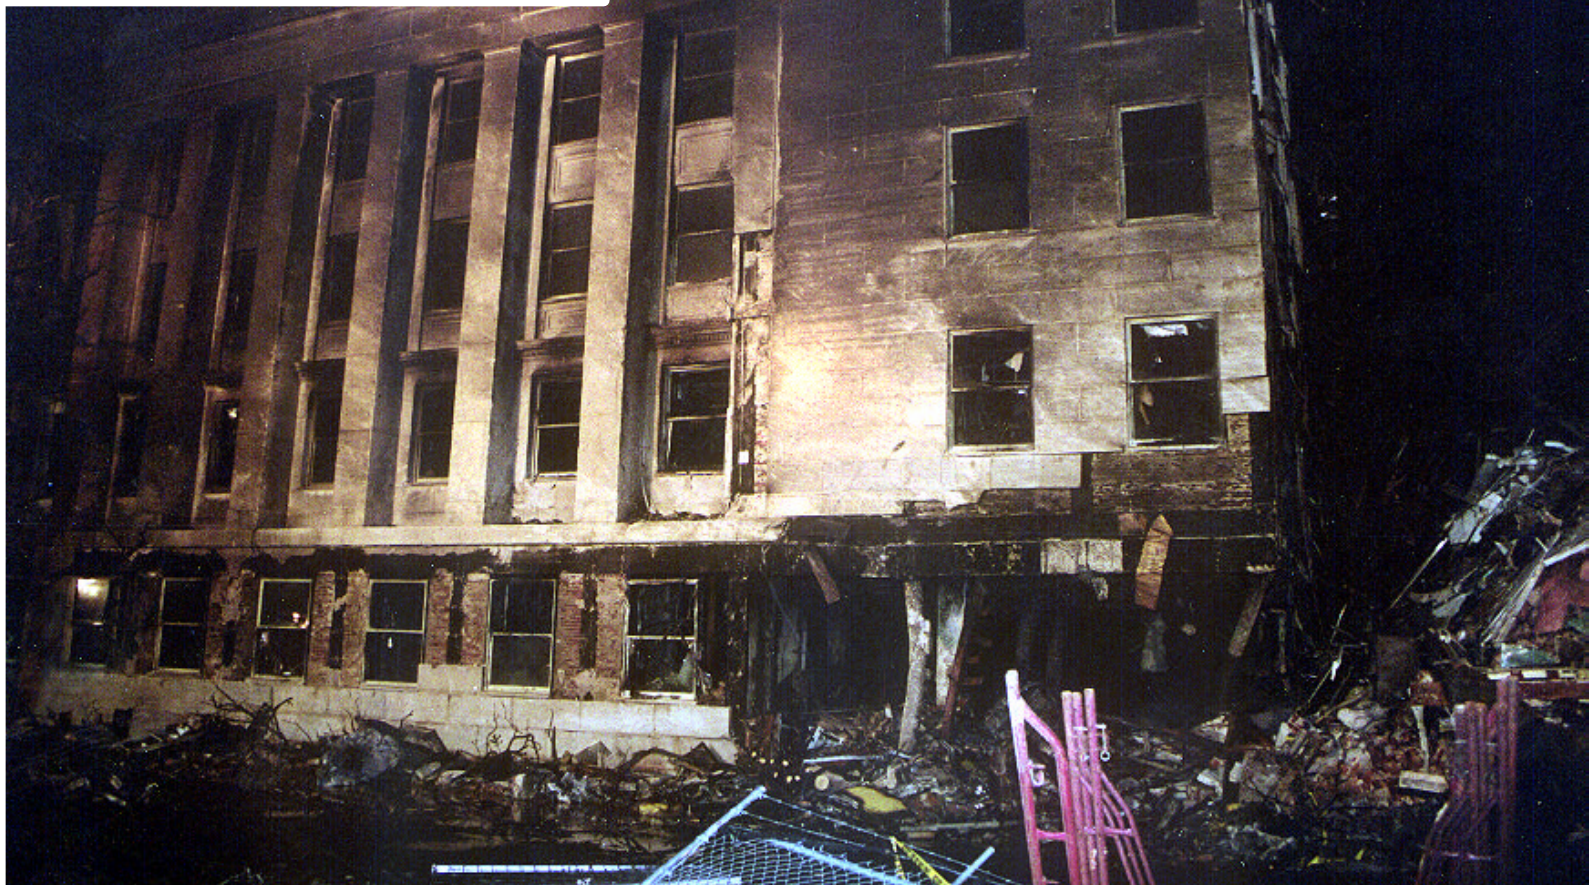
Temporary columns were erected to provide support where the original columns had been demolished.

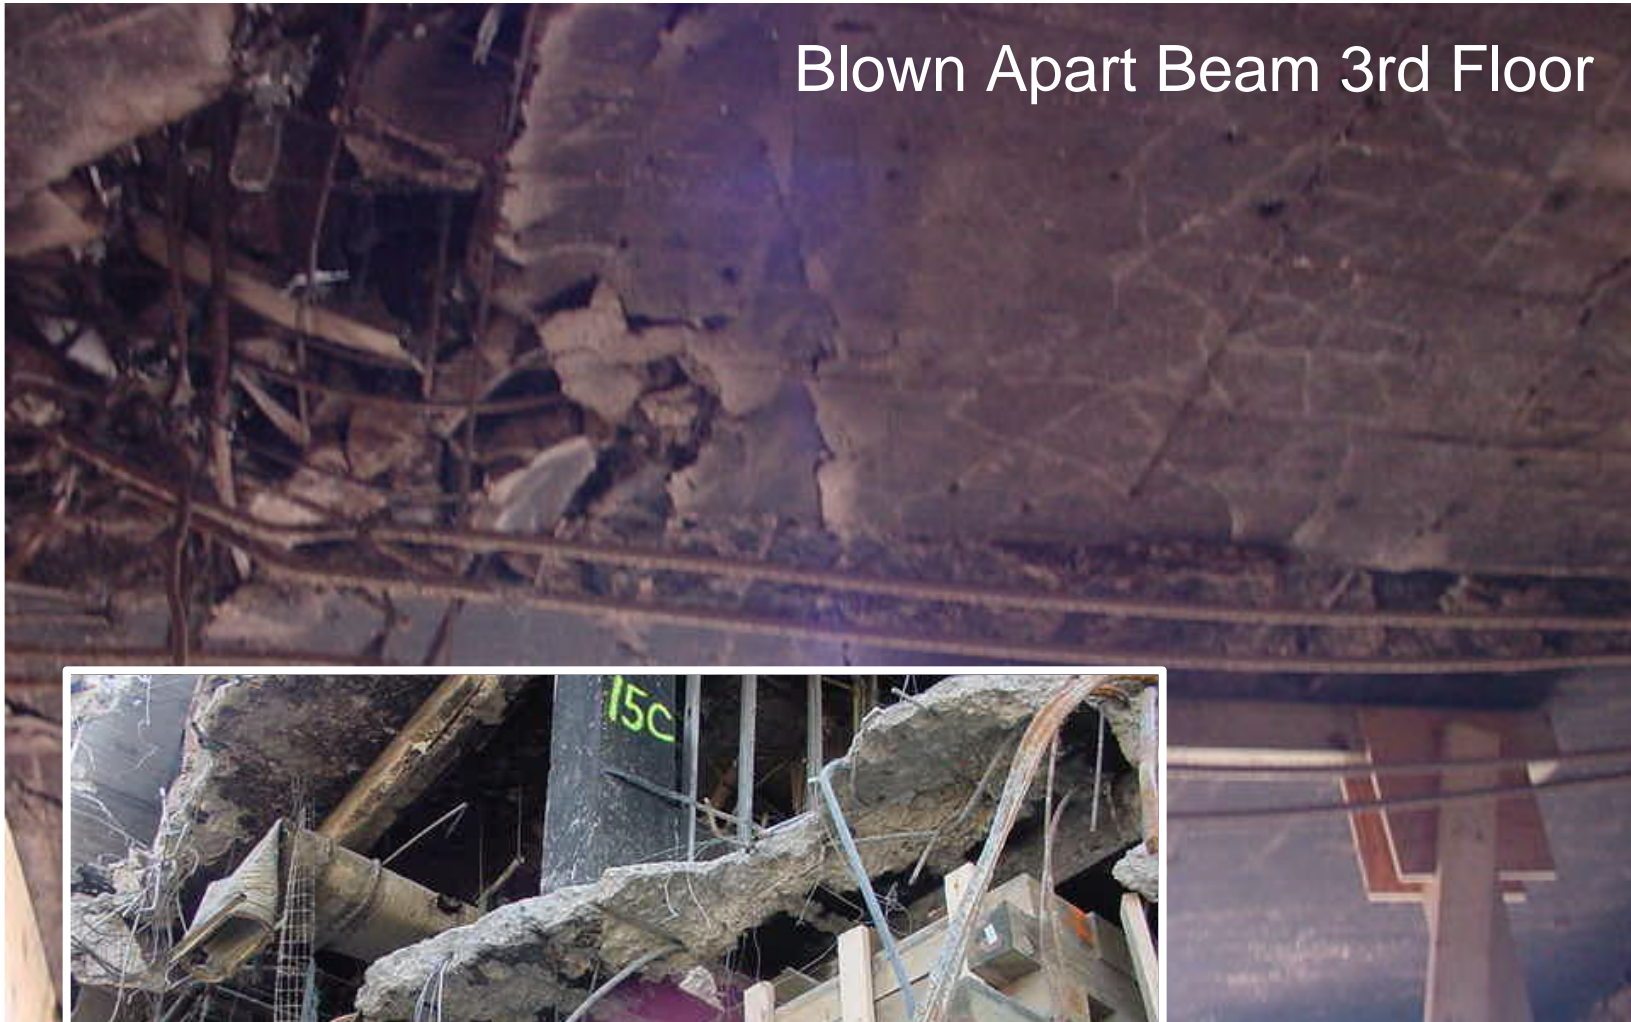
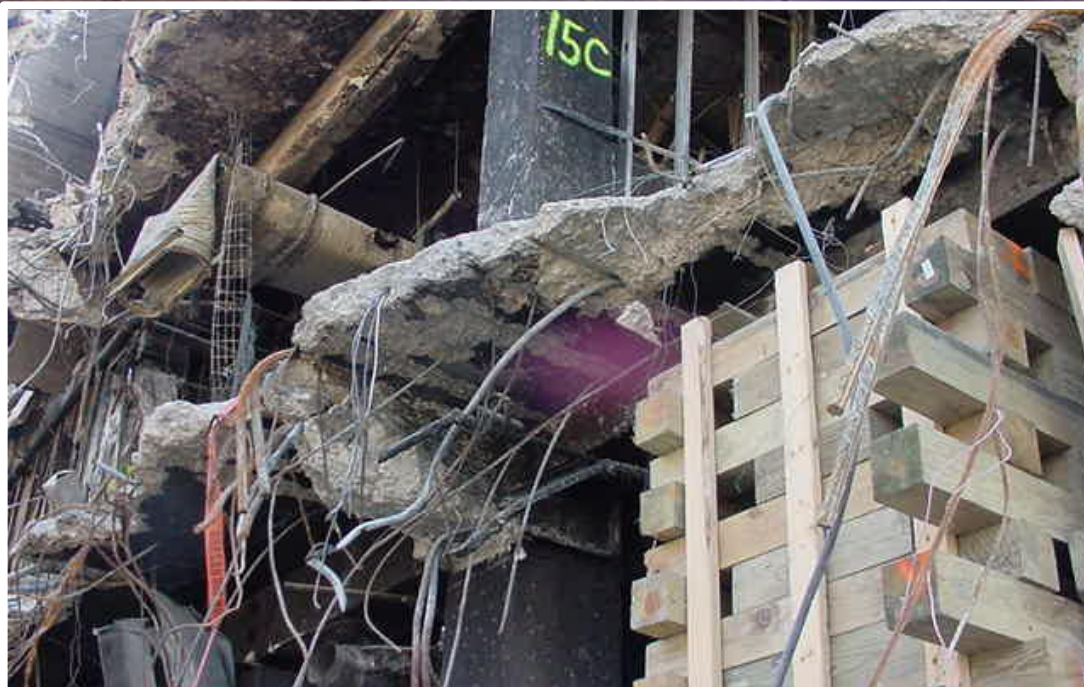
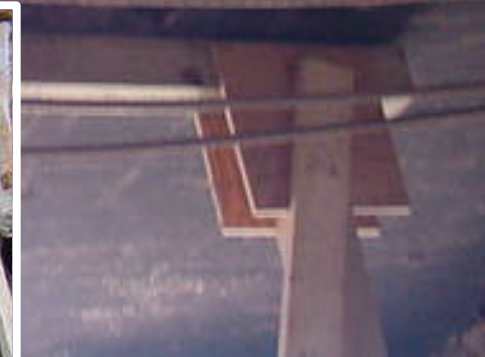
Blown Apart Beam 3rd Floor

Looking Up At
Collapsed Area.
Note Missing
Columns

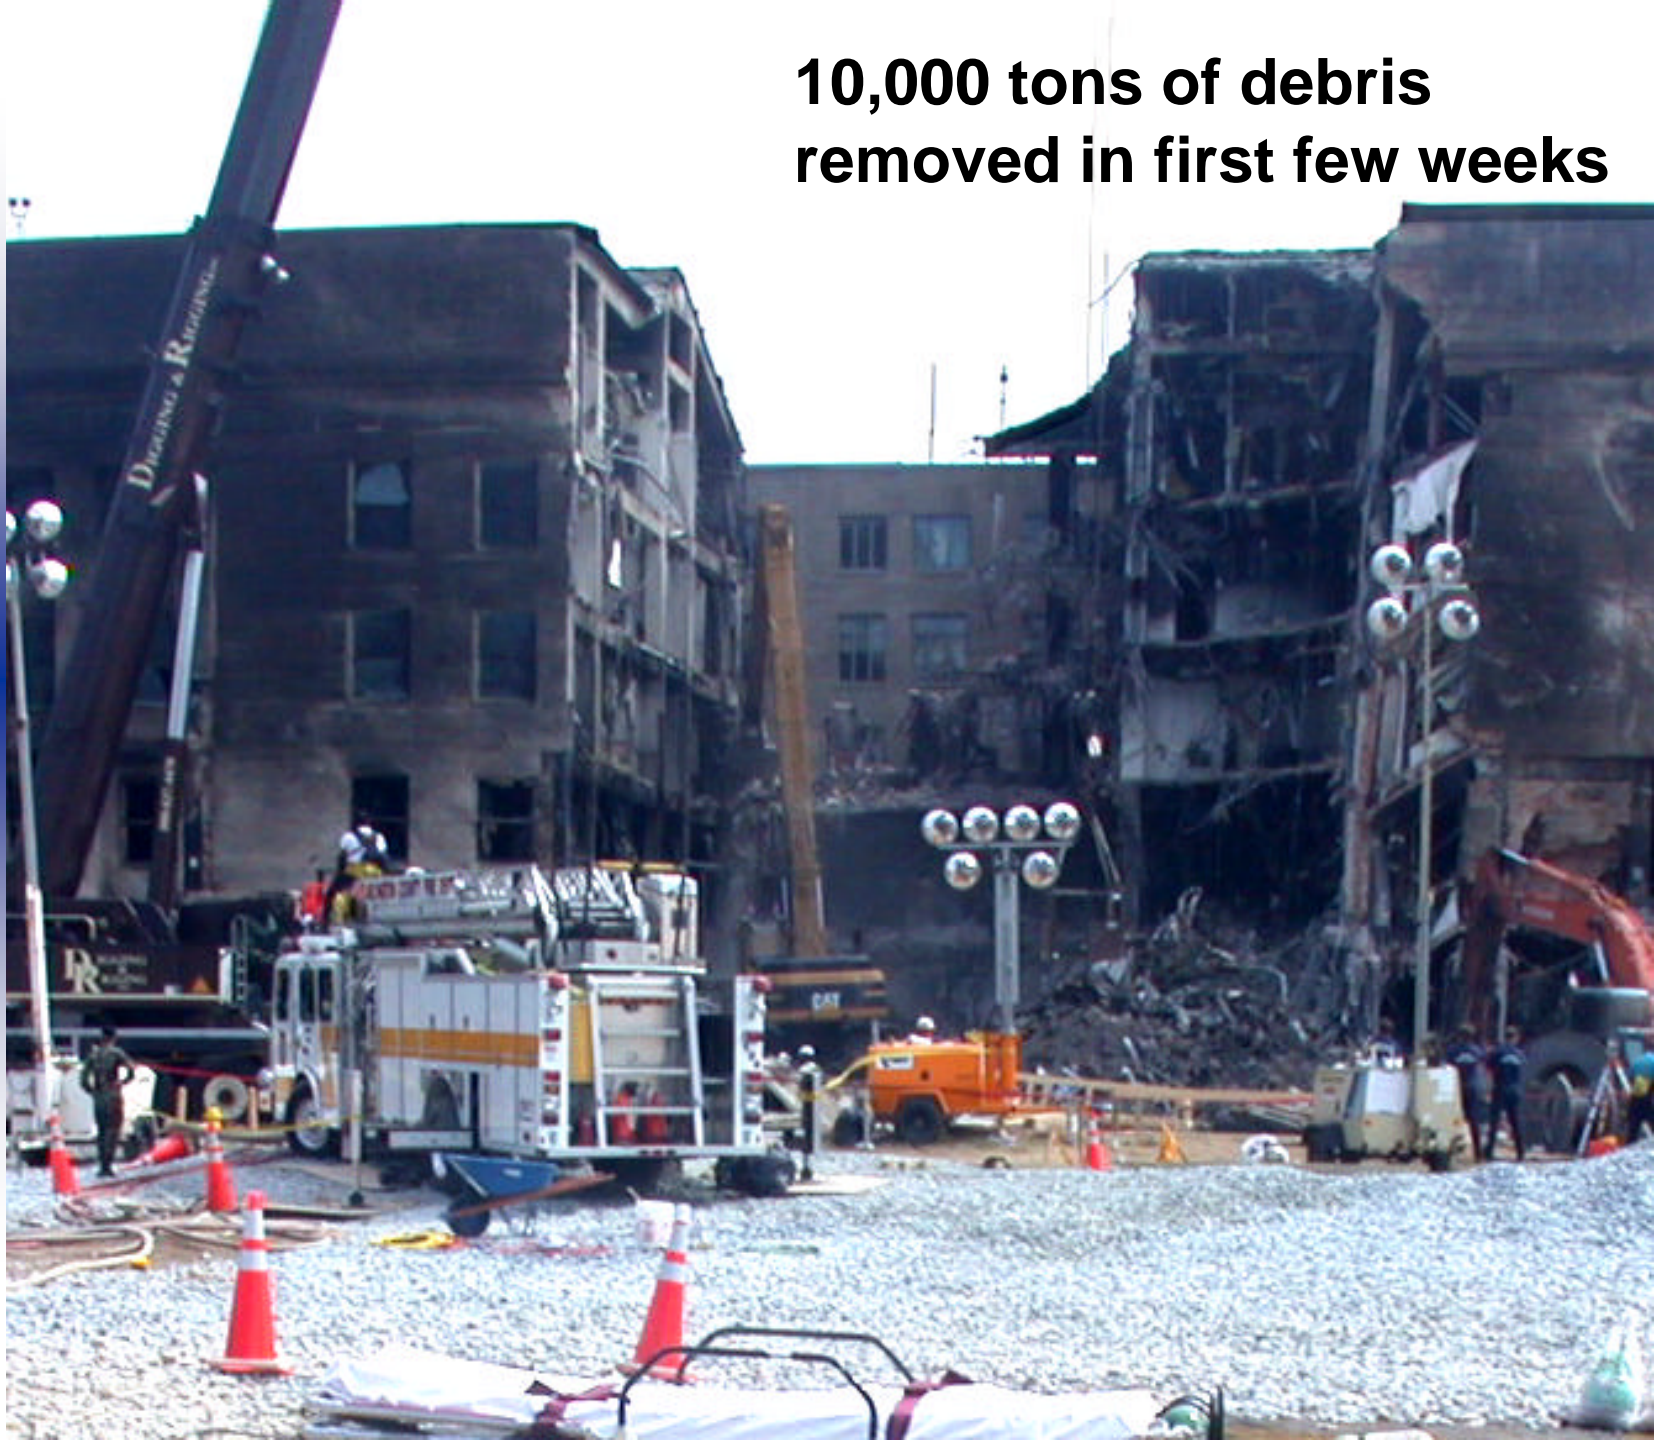
STRUCTURAL DAMAGE

- MISSING
- STRIPPED & BOWED
- STRIPPED CAGE
- SOME DAMAGE
- COLLAPSED AREA

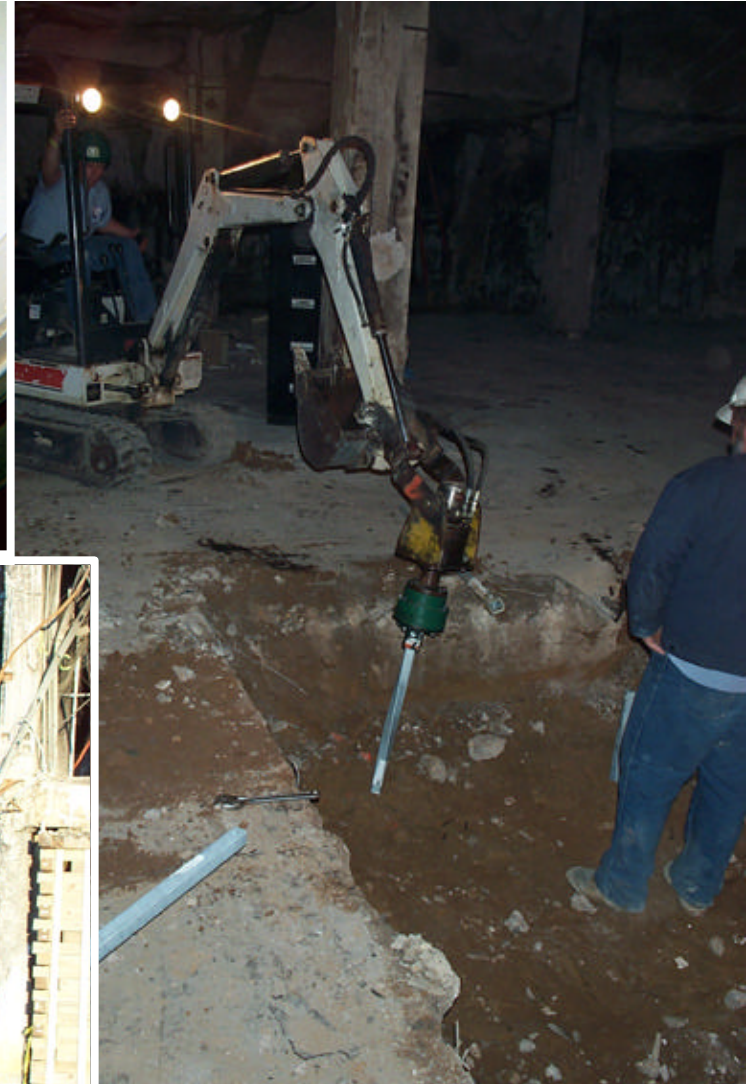
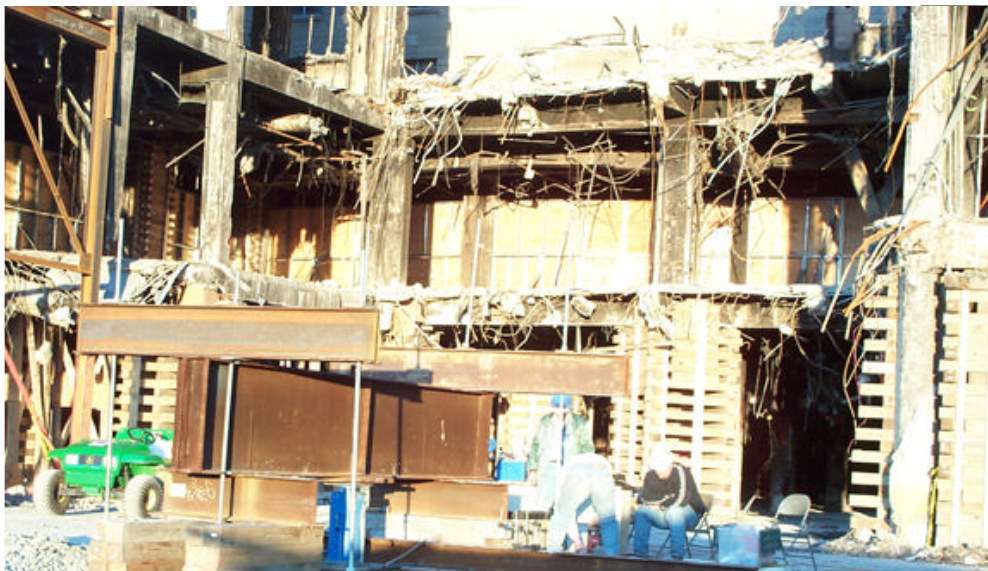
Sampling Concrete

Helical Anchor Piles

Pile Load Test in Collapse Area

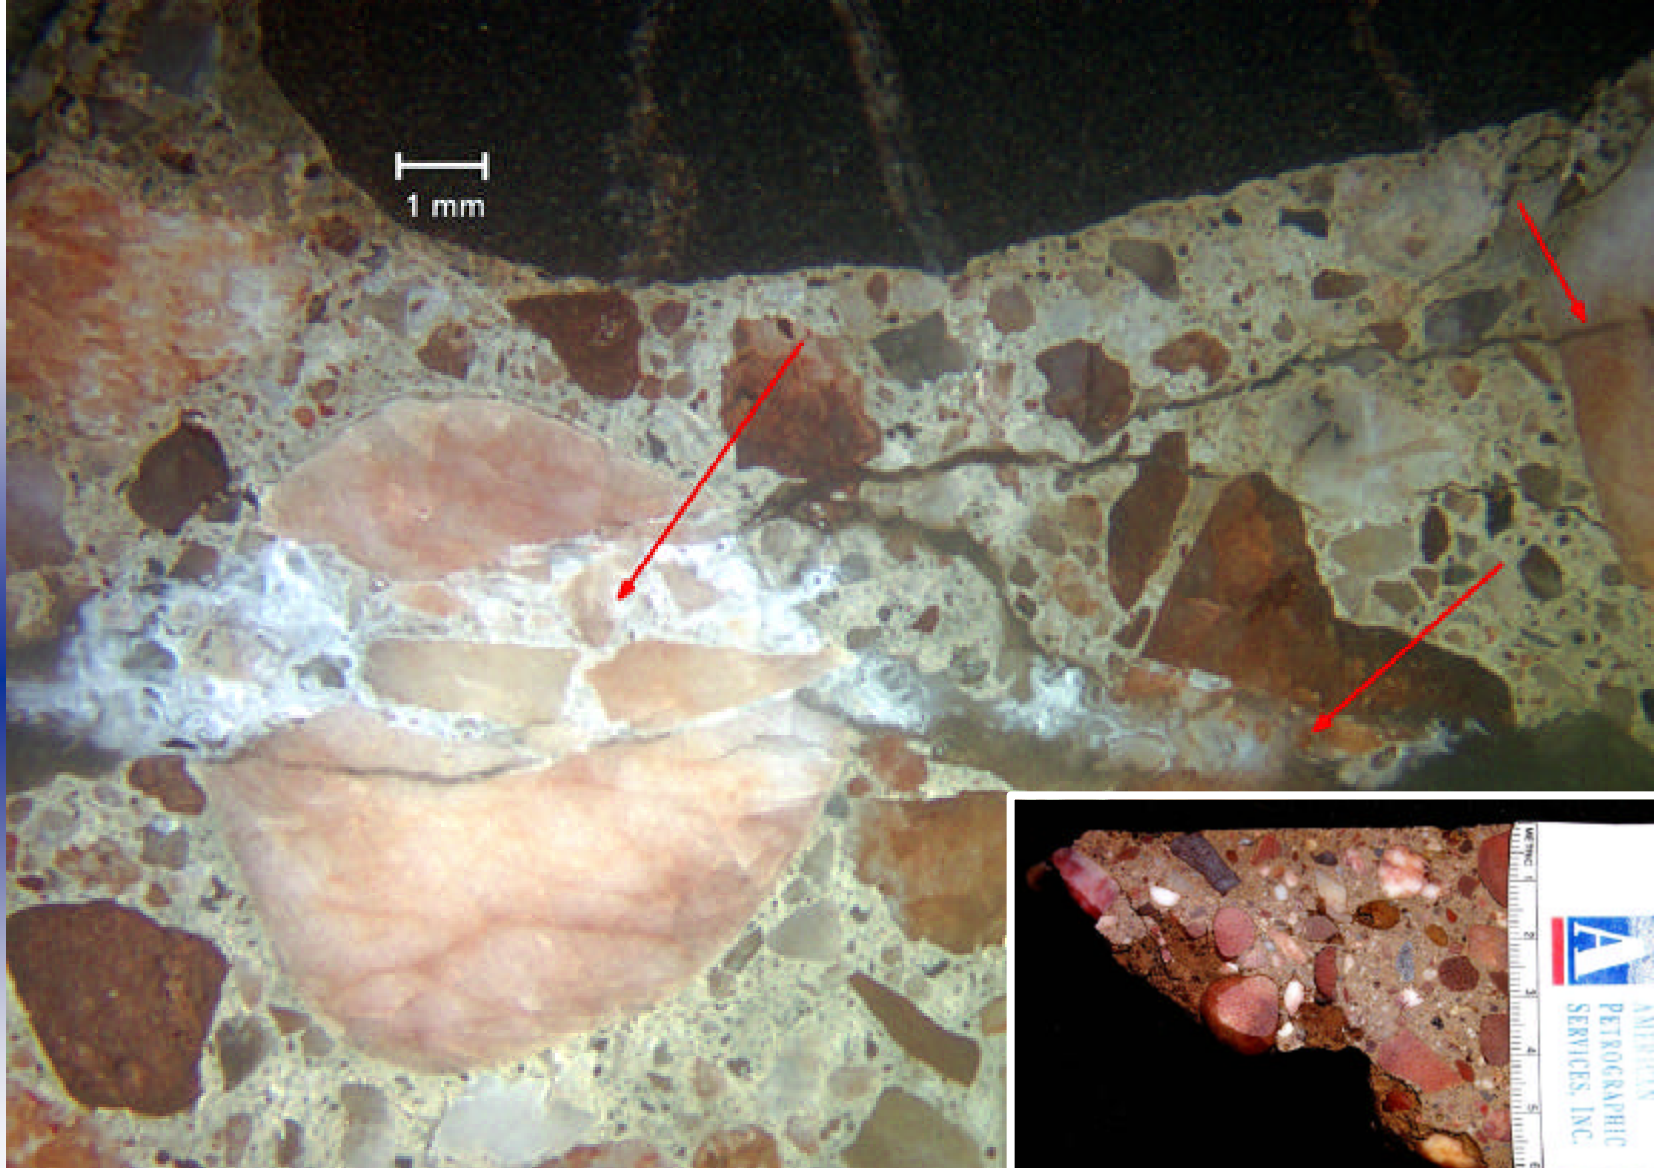
Saw-cut cross section of concrete from the support columns showed numerous micro-fractures.

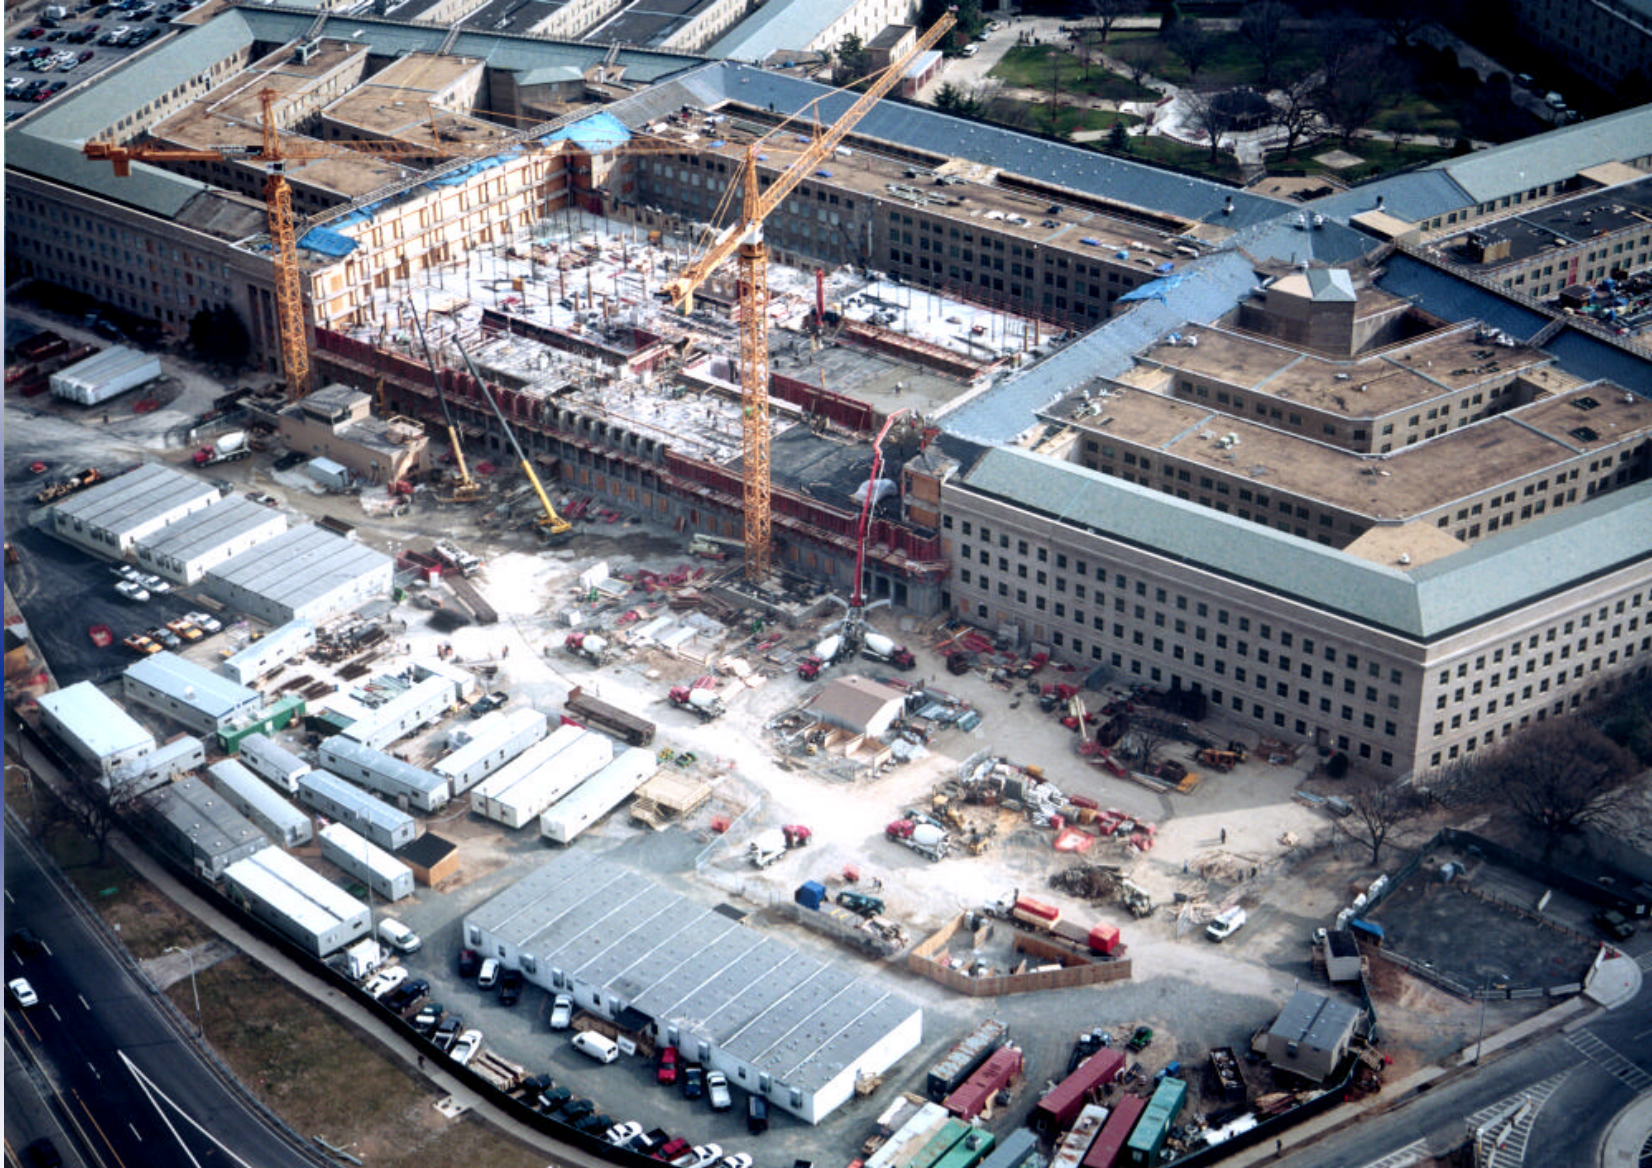
February 13, 2002: Third floor deck is nearly finished, and work begins on support columns for the fourth floor.

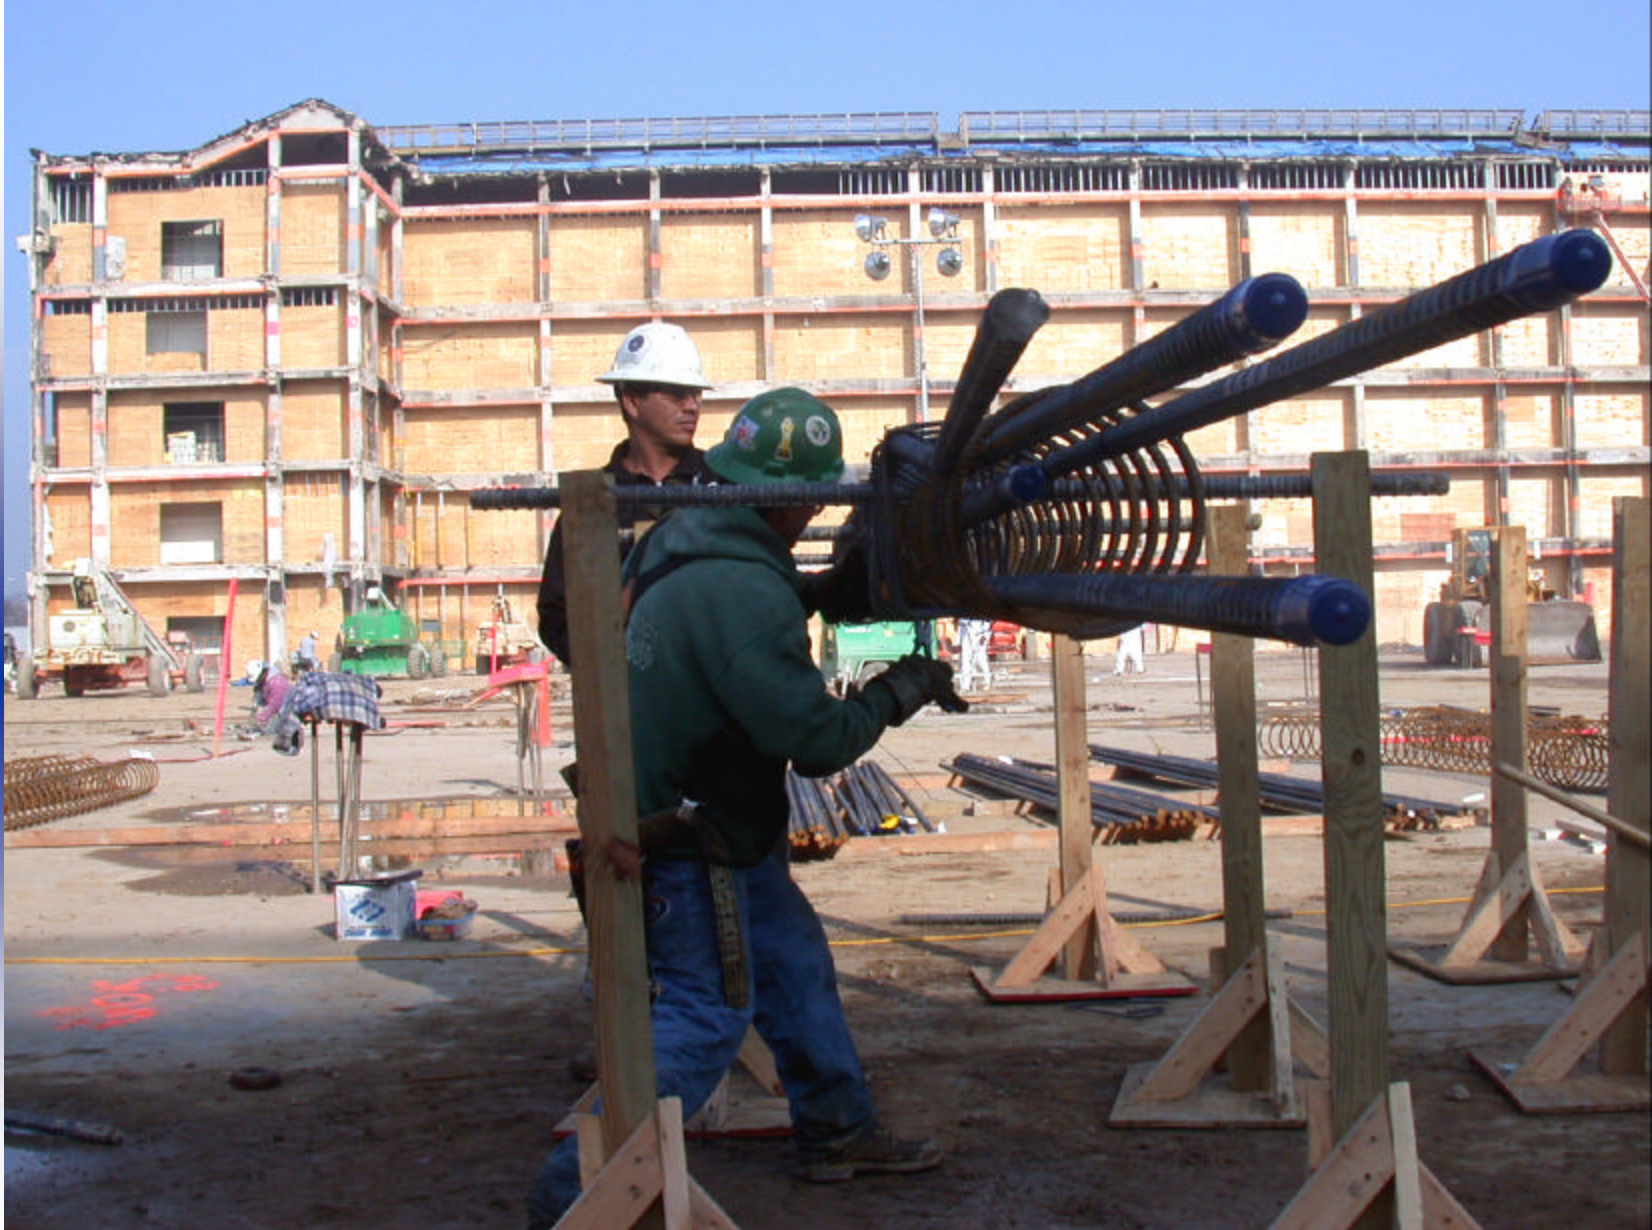
**Reconstruction began November 19, 2001.
A steel cage of spiral rebar is formed.**

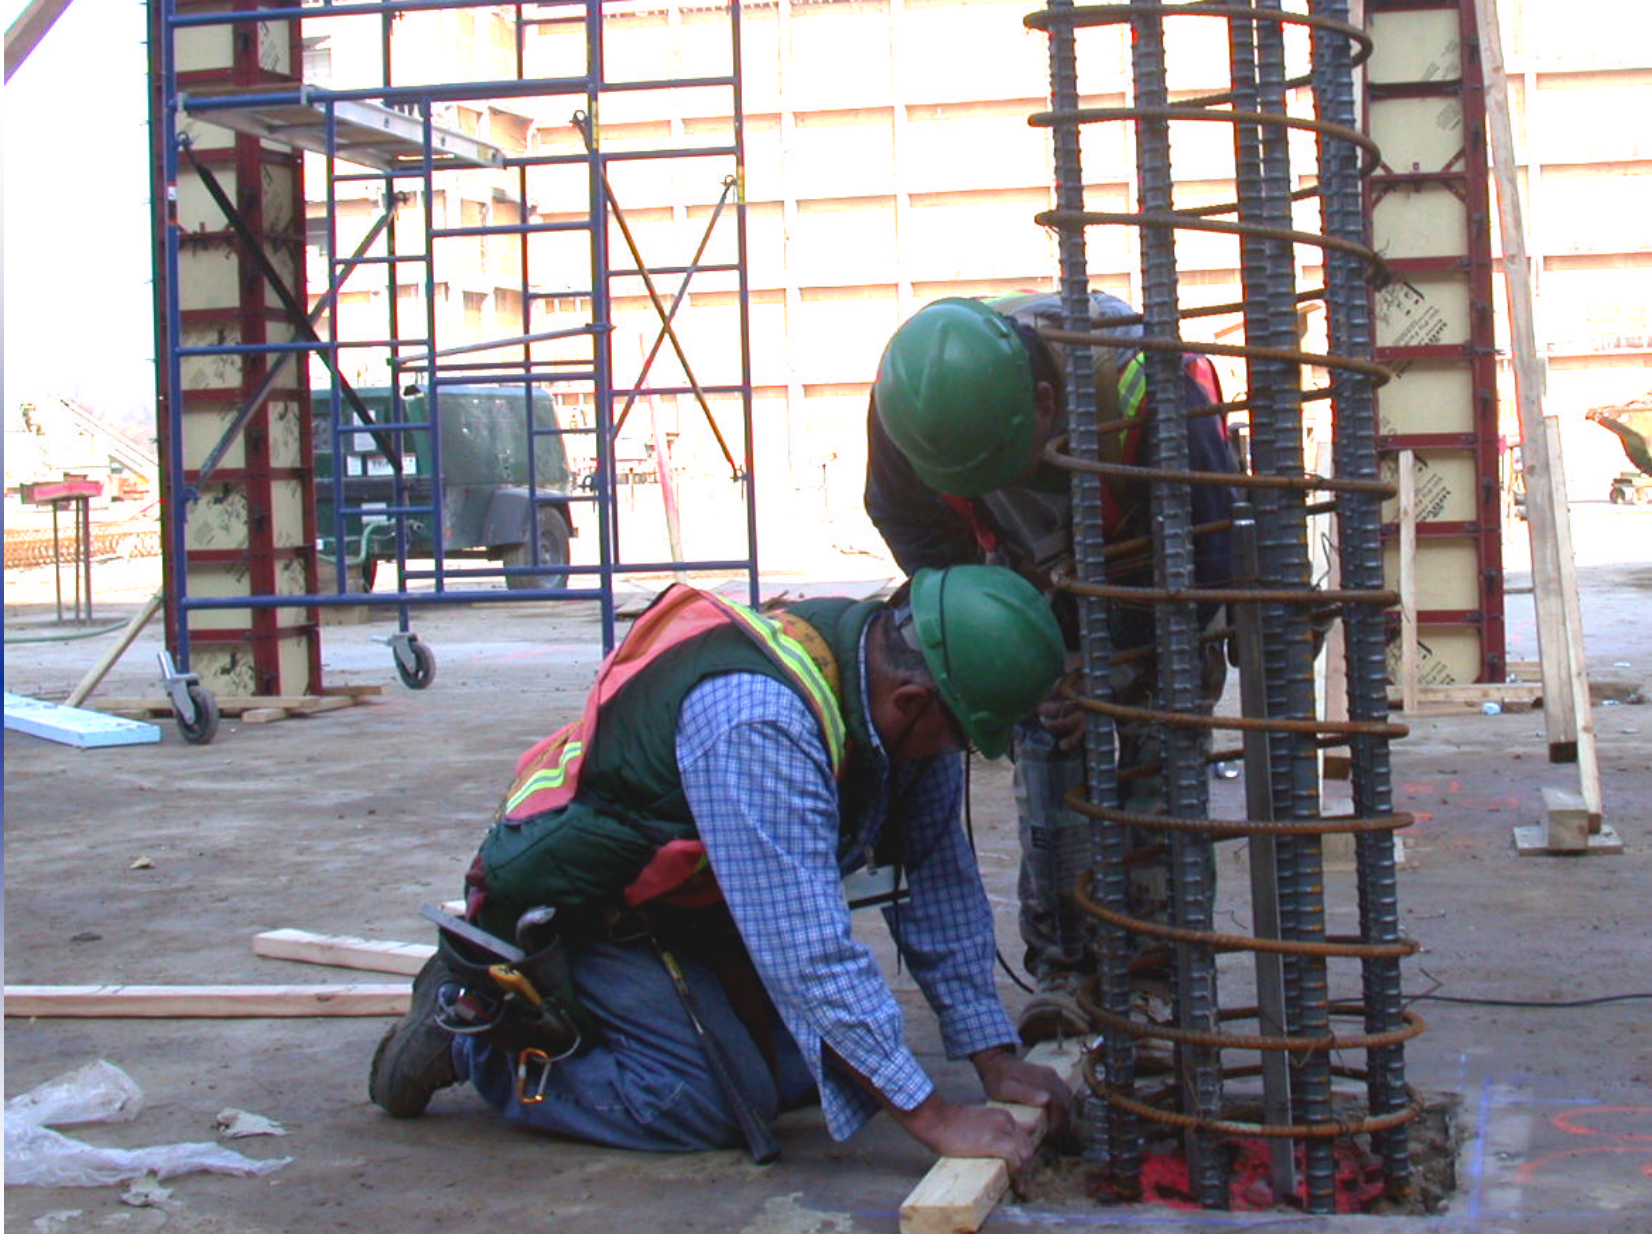
**Rebar cage is joined to 1.25" high strength,
stainless steel dowel rods planted in concrete slab.**

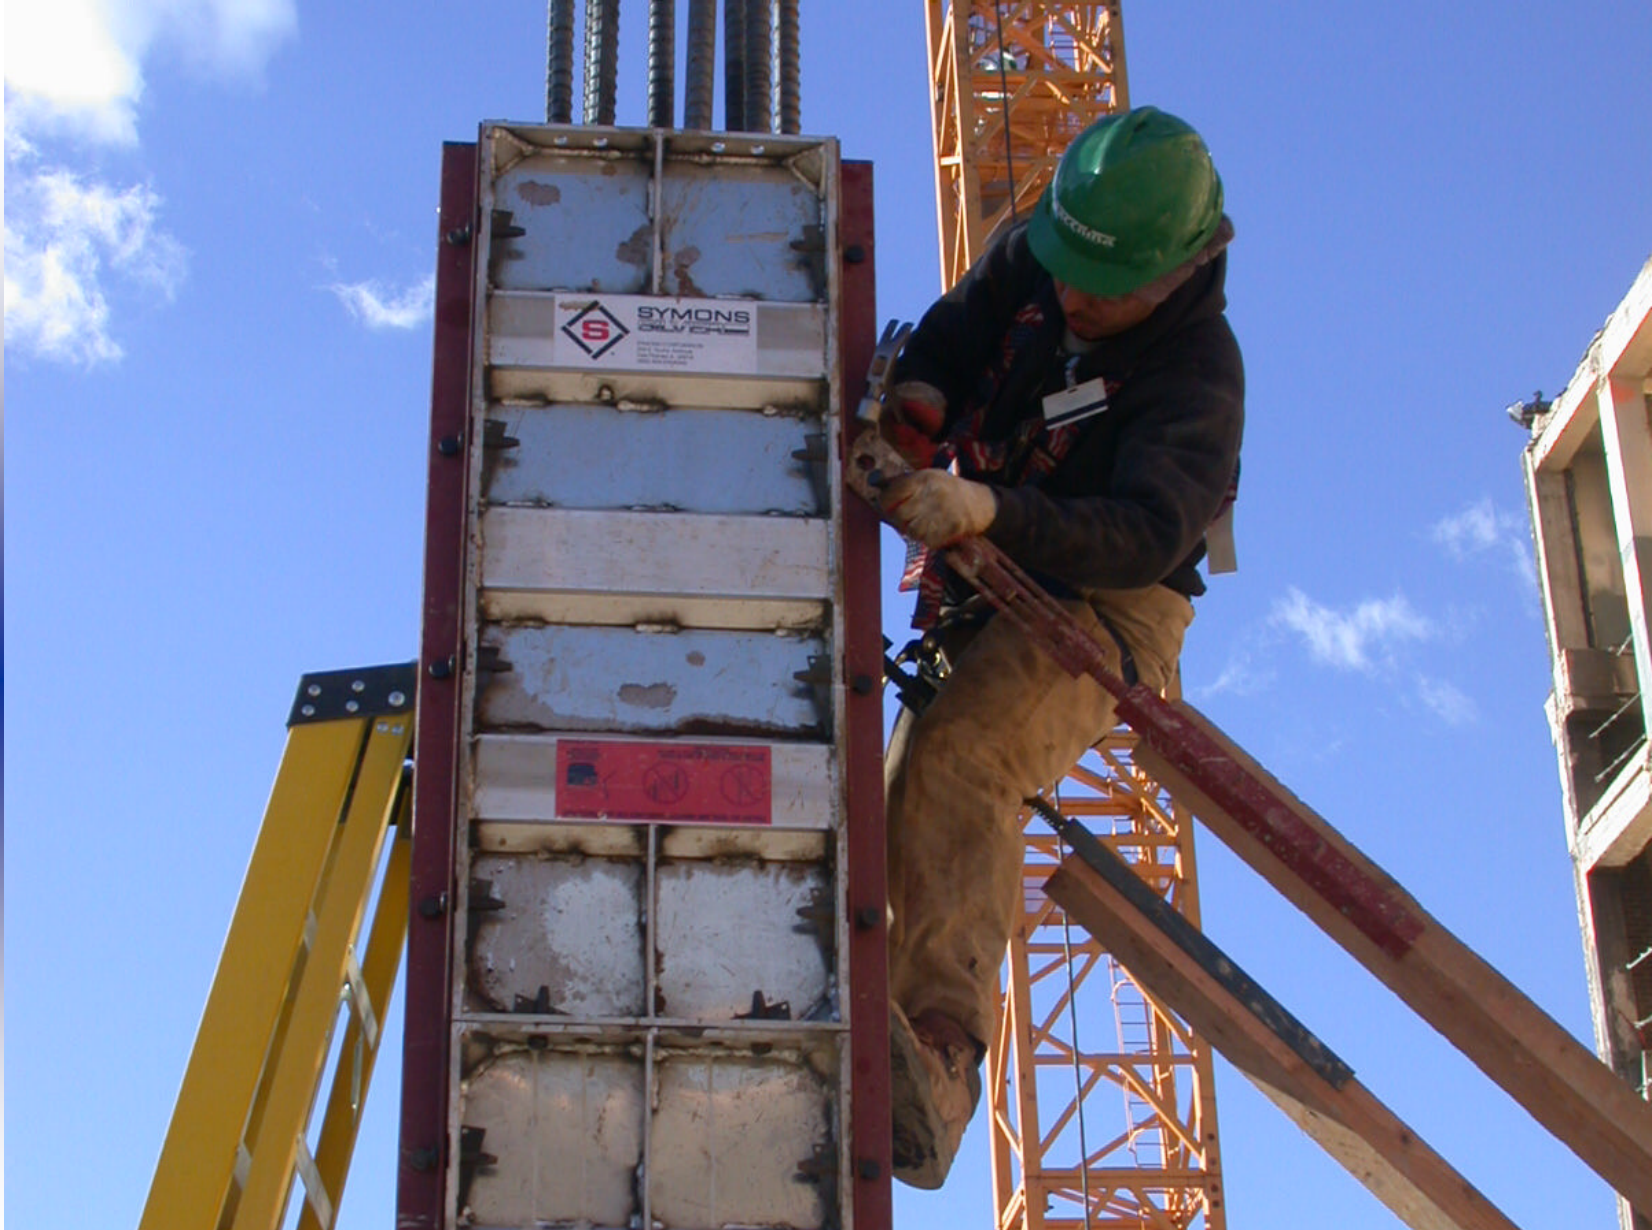
Formwork is secured around steel rebar.

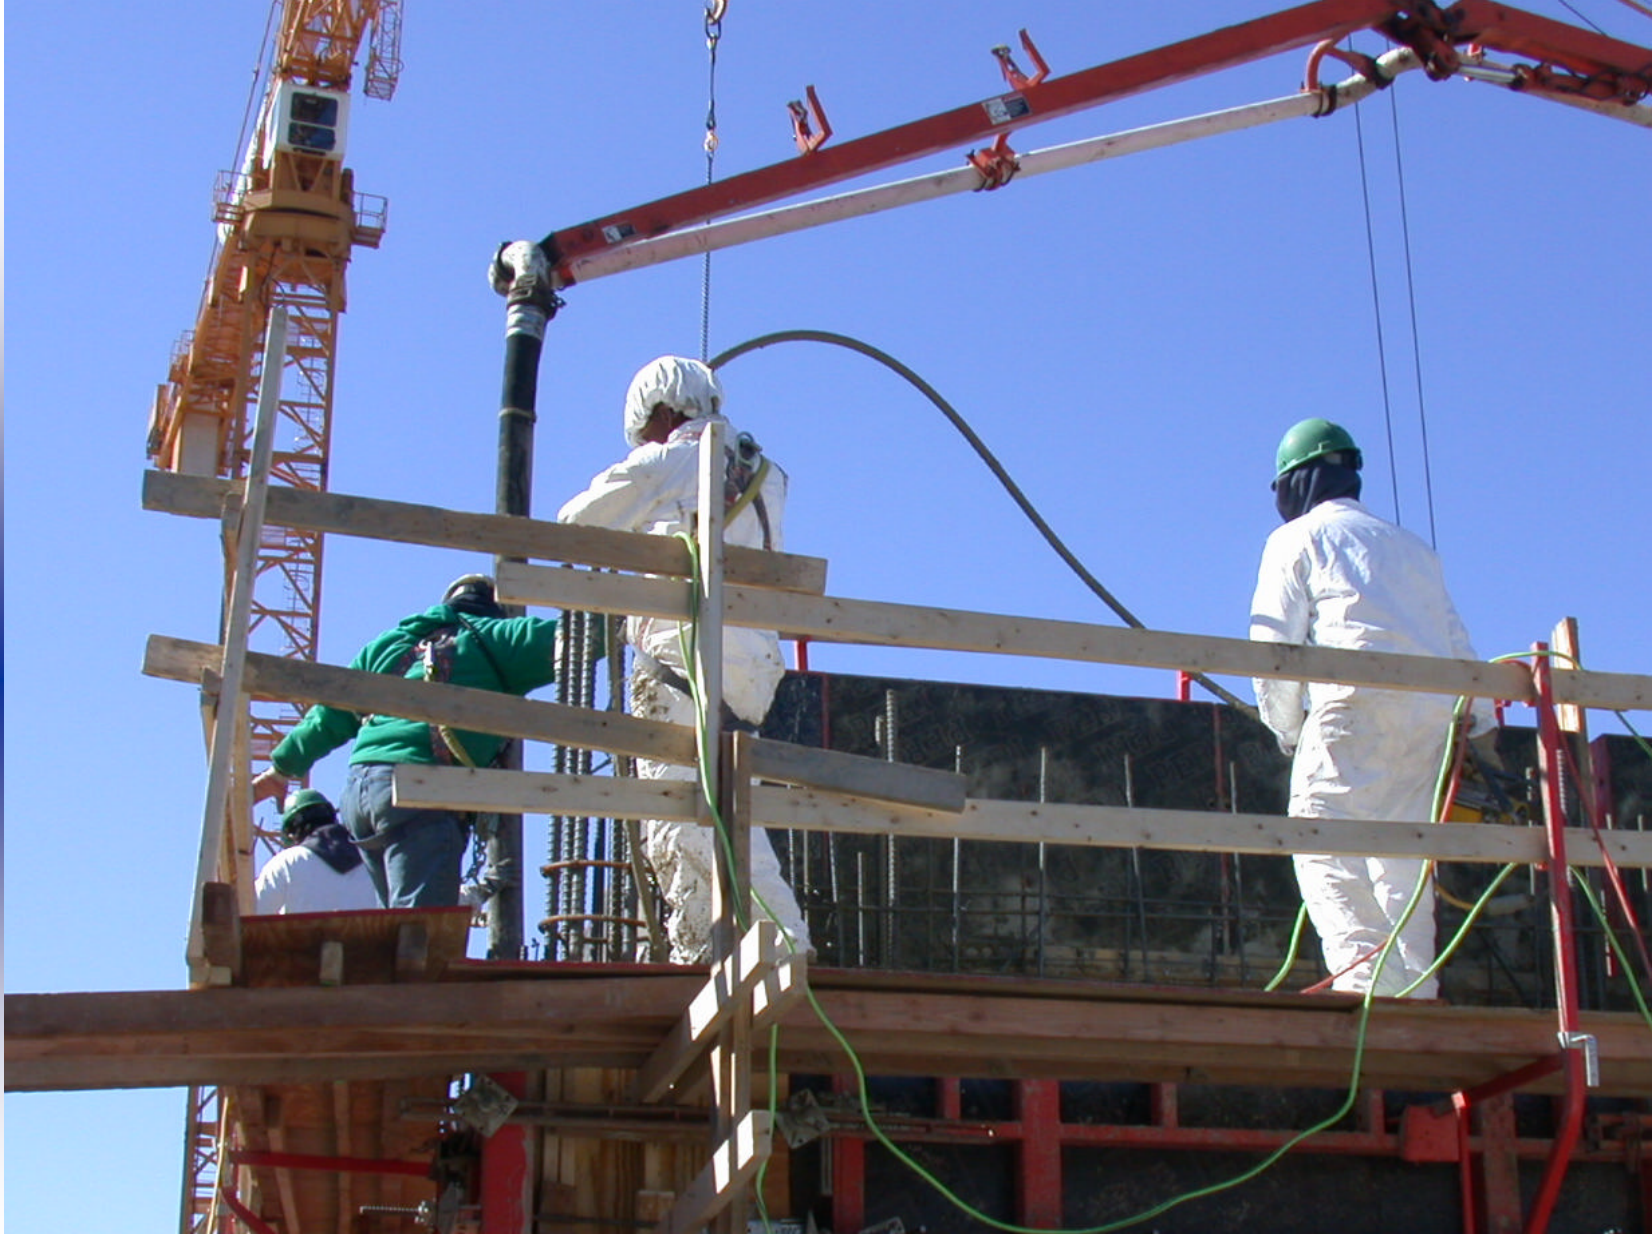
Concrete is poured into the top of the formwork.

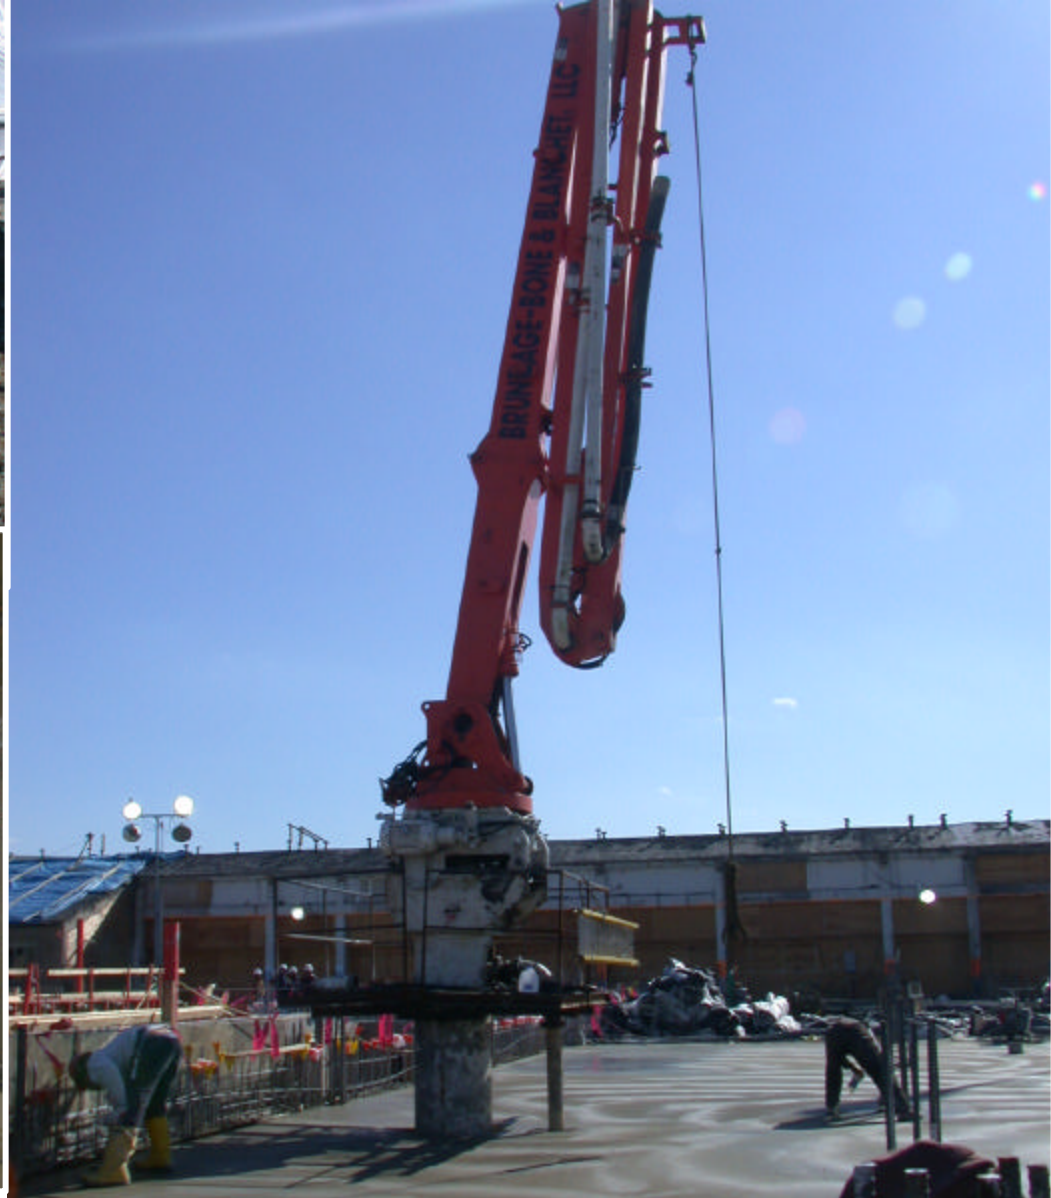
Concrete is pumped to the upper floors through a line that runs from the outside of the building.

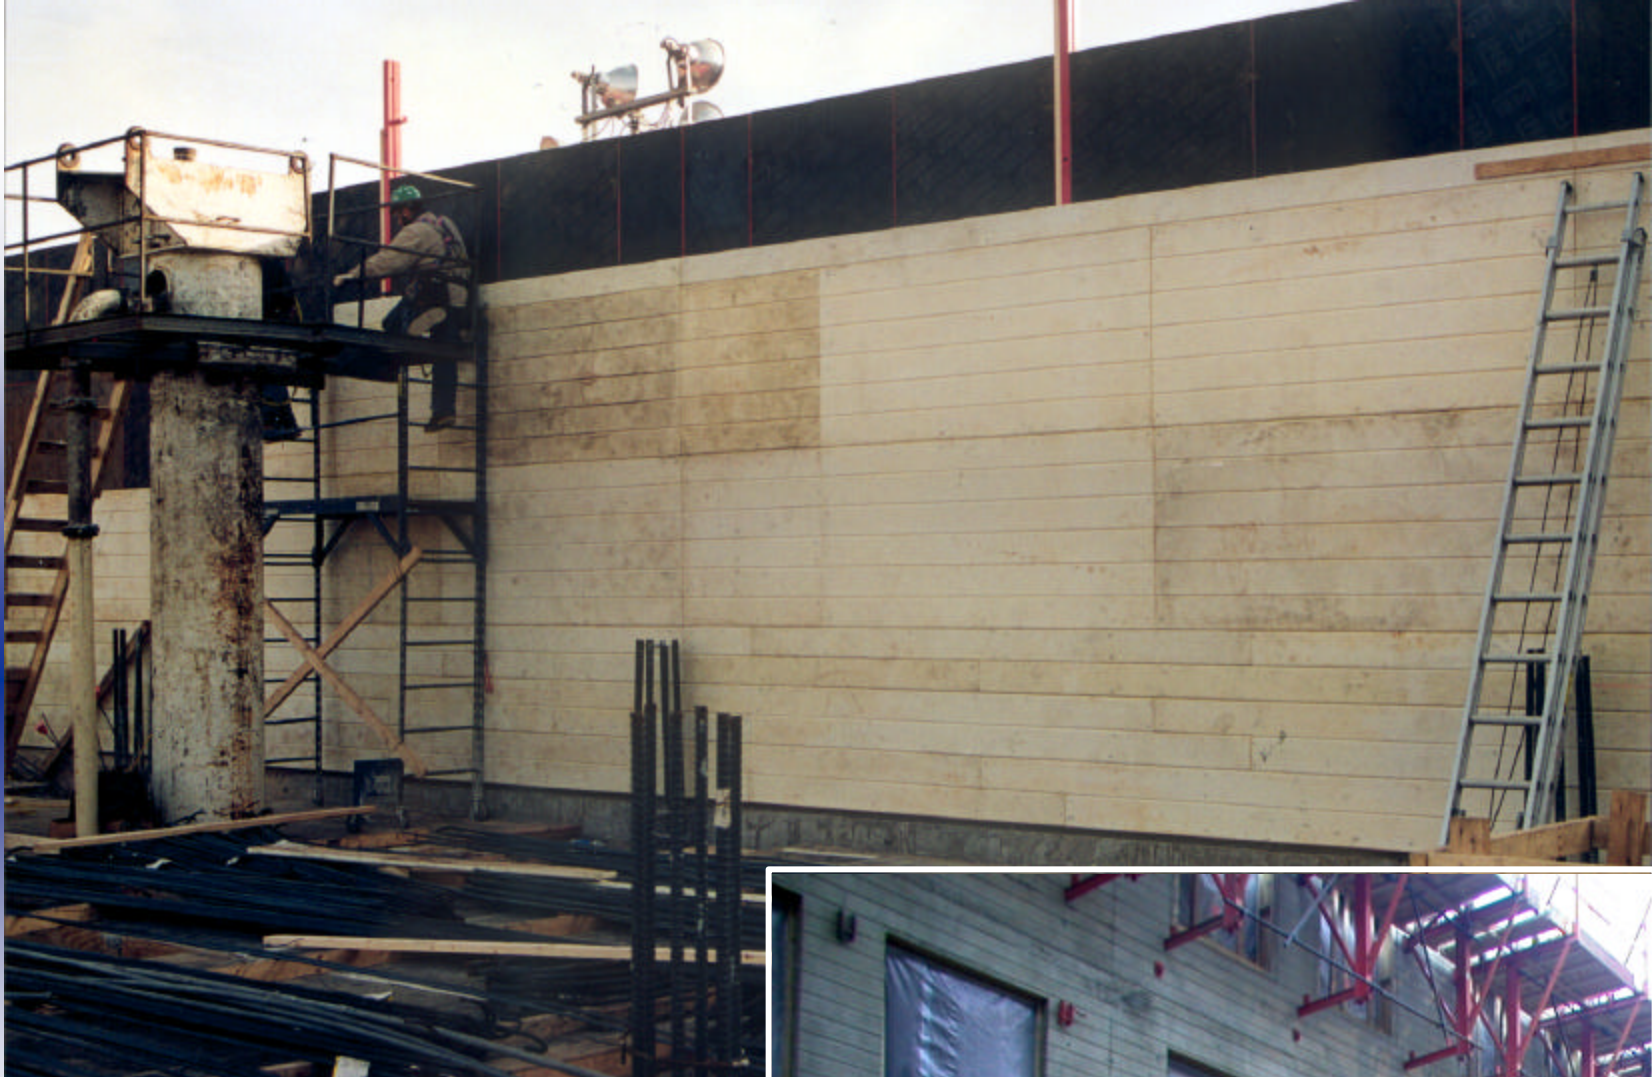
**Plastic formwork liner
replicates the look of
original 1941 structure.**
